Treatment for MCW Pump Impeller

Waste Water Treatment Plant

July 2021.

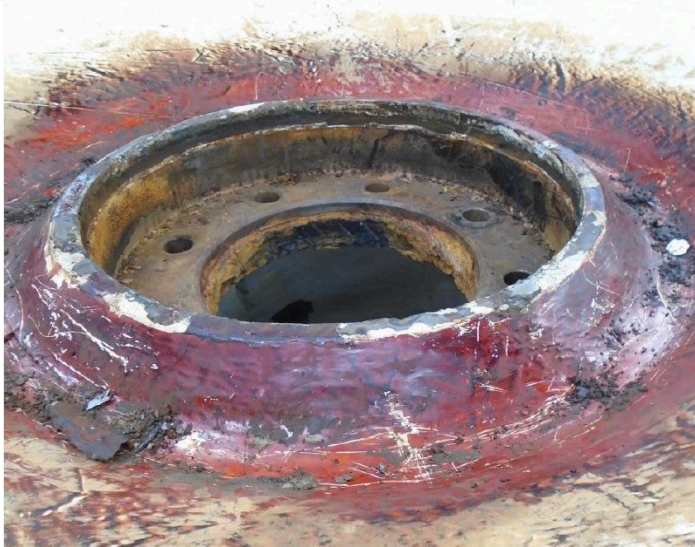
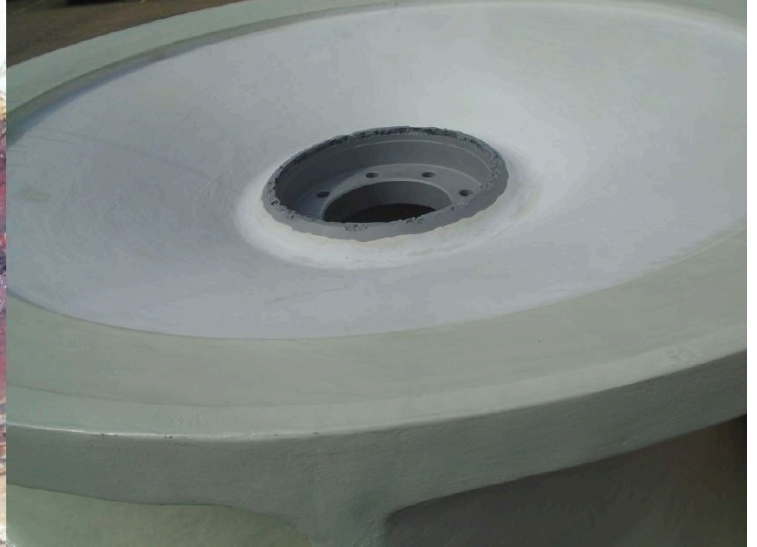
Repair and coat damaged areas of main colling water pump impeller which experienced erosion corrosion as a result of everyday use.

- Grit blasted to ISO 8501-1 Sa 2½
- Corroglass 600 series hand applied, with relative humidity <85% and steel temperature 30°C or greater than moisture dew point, to achieve a minimum of 1500 microns DFT.

For corrosion protection, thickness is normally 750 microns DFT average. For areas with increased wear, thickness increased to 1500 microns.
