Urgent Offshore Repair of 94 Flange Faces Affected by Crevice Corrosion

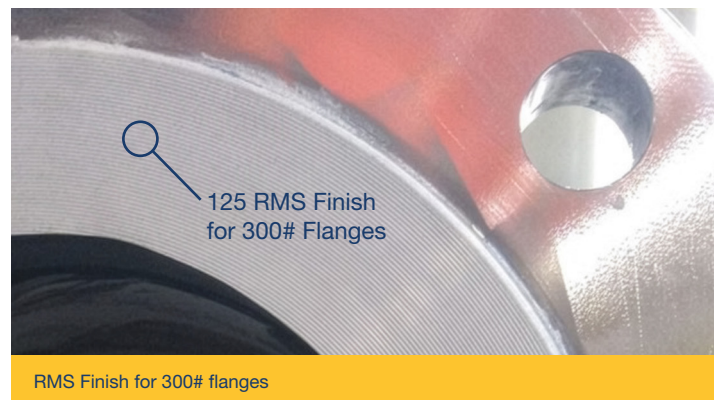
A total of 94 flange faces, ranging from 1" to 8" ID, had developed early-stage crevice corrosion. A previous repair had already failed, leaving the assets vulnerable to further degradation and potential leakage.

- Controlled surface preparation using a combination of vacu-blasting and traditional abrasive blasting within containment
- Installation of former plates and application of release agents to achieve precise casting geometry
- Rebuilding of flange faces using Plasmet HTE, selected for its high compressive and tensile strength
- Careful in situ application to ensure durability under demanding offshore operating conditions

- Successful restoration of all 94 flange faces in 9 working days
- Successfully passed nitrogen pressure testing following first application
- Returned to service within 24 hours of polymer coating installation
- Prevention of further crevice corrosion and degradation of the sealing surface
- Long-lasting, durable repair suited to offshore conditions
