## Repair and Overhaul of four River Water Pumps following pump house flooding

## Pump Suction Cover Repair

## Repairing Ballast Pump for an FPSO

## Protection for Pump Wetted Areas

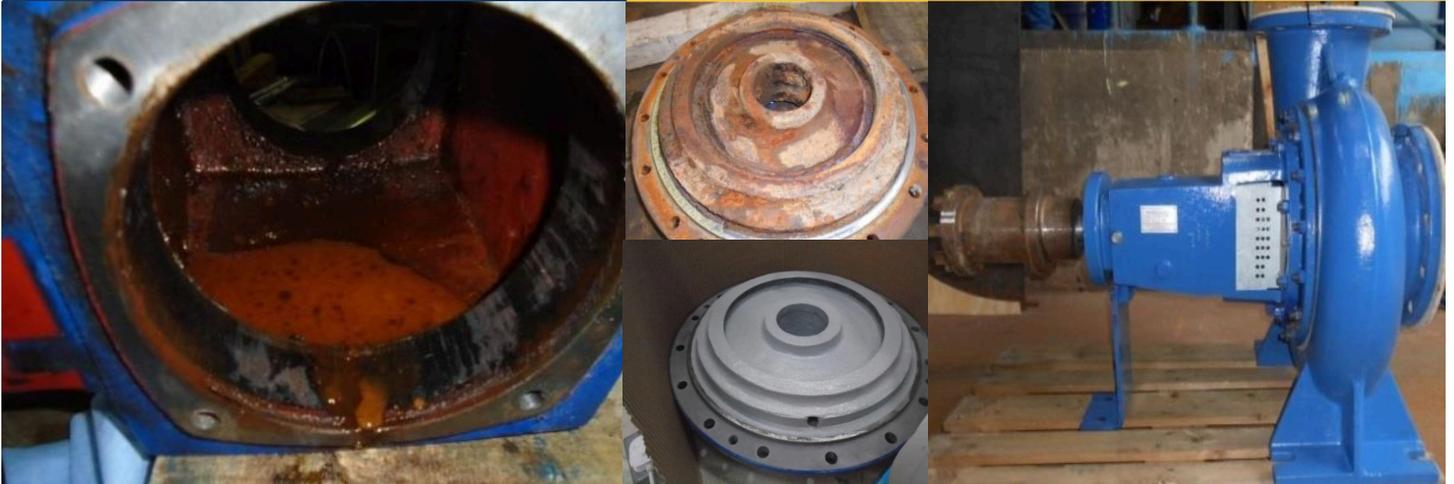
Corroserve's dedicated pump division was approached to repair and service four feed water pumps for a gas fired power station. Not only does the river water used have a very high silt content, but the pump house itself suffered from flooding, which fully submerged the pumps.

Each pump was taken out of service in turn and delivered to our workshop. After arrival the service team dismantled the pump and completed a strip and inspection report. As can be seen in the images above, the wetted areas suffered from erosion corrosion and due to flooding, the bearings were badly damaged.

The professional preparation of the wetted parts before coating and the use of Plasmatec HTE ensured that the pumps will remain in service for many years.

The specialist coating used is designed to provide protection against corrosion in immersed locations and offers resistance to highly abrasive pumped products.

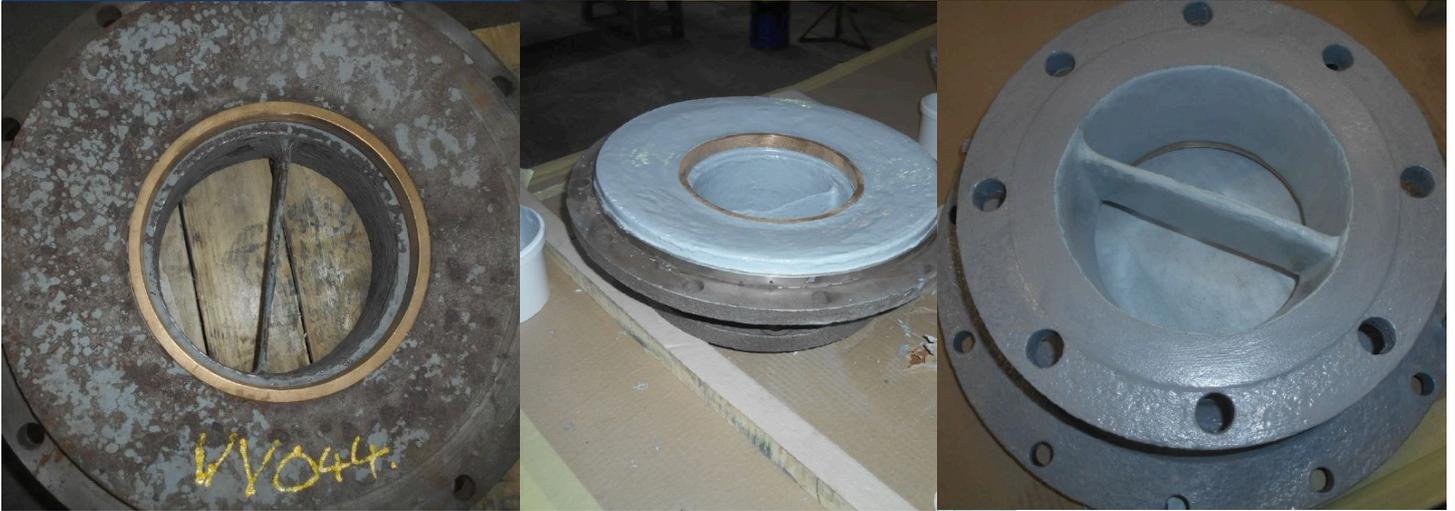
Repair the suction cover back to original dimensions. Then to also give better protection to the substrate from the abrasive pumped media.

Left - suction cover as received from the client

Middle - Suction cover during coating process

Right - Suction cover finished and ready for dispatch back to client

Corrosolve proposed to rebate and pre-machine to accommodate the coating process. Masked the areas not requiring treatment. Grit blasted to ISO850-1, internals and all wetted areas to Sa2.5 and externals to Sa2. Then applied multiple coats of Plasmatec HTE (data sheet 5/05A) to achieve a minimum DFT 2.0mm to the pump internals, thickness checked and spark tested. Post machined as required. Then finally applied two coats of Plasmatec ZF (data sheet 5/22 ) to the suction cover external areas.

The suction cover was returned back to its original dimensions, with the added benefit of being more abrasion resistant due to the Plasmatec HTE coating. Plasmatec HTE is a viscous, solvent free, amine cured epoxy containing stainless steel flakes, glass flakes and silicon carbide. It has excellent abrasion and chemical resistance in immersed environments and is also useful for building up damaged areas where impact or abrasion are prevalent.

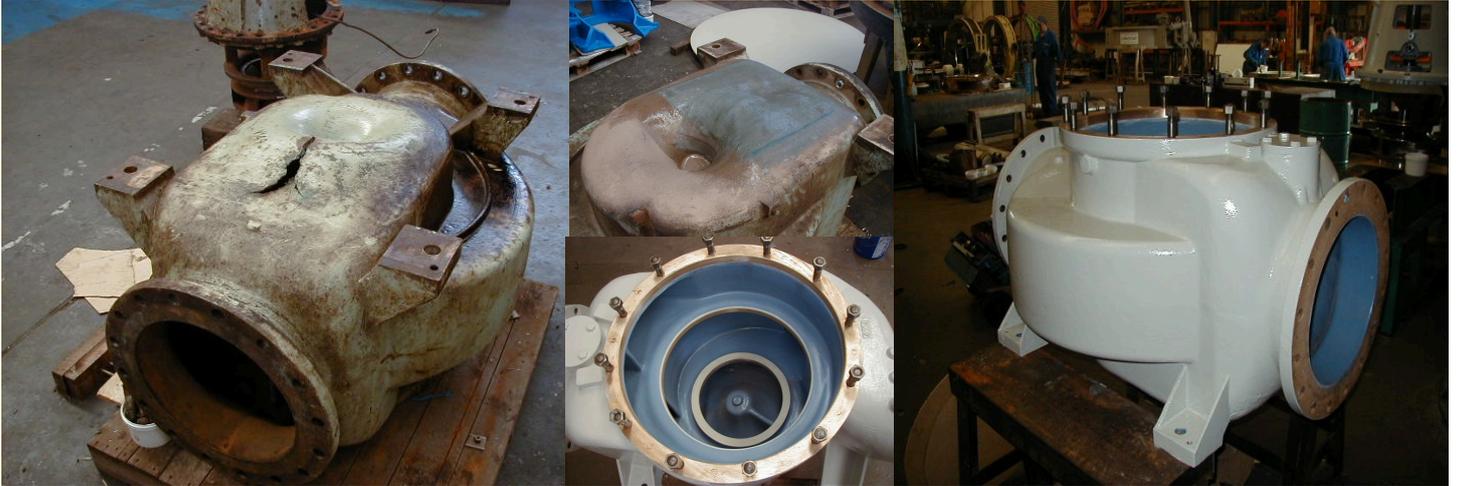
Corroserve was approached by the client to repair a badly damaged ballast pump casing. As can be seen in the images above, the pump had pulled in a large item that had cracked open the casing at the bottom of the suction chamber.

After arrival at our workshop the service team cut out the affected area and welded in a new bronze plate, prepared volute casing by abrasive blasting the surface to a Sa2 1/2 to provide a minimum surface profile of 50 microns. They then laminated over the affected area inside and out. Finally, the casing was coated with Corroglass 600 series to a DFT of 1.25mm inside and painted to the requested RAL outside.

The professional preparation and repair of the casting before coating and the use of Corroglass 600 will ensure that the casting will be in service for many more years. The specialist coating used is designed to provide protection against erosion corrosion in immersed conditions.

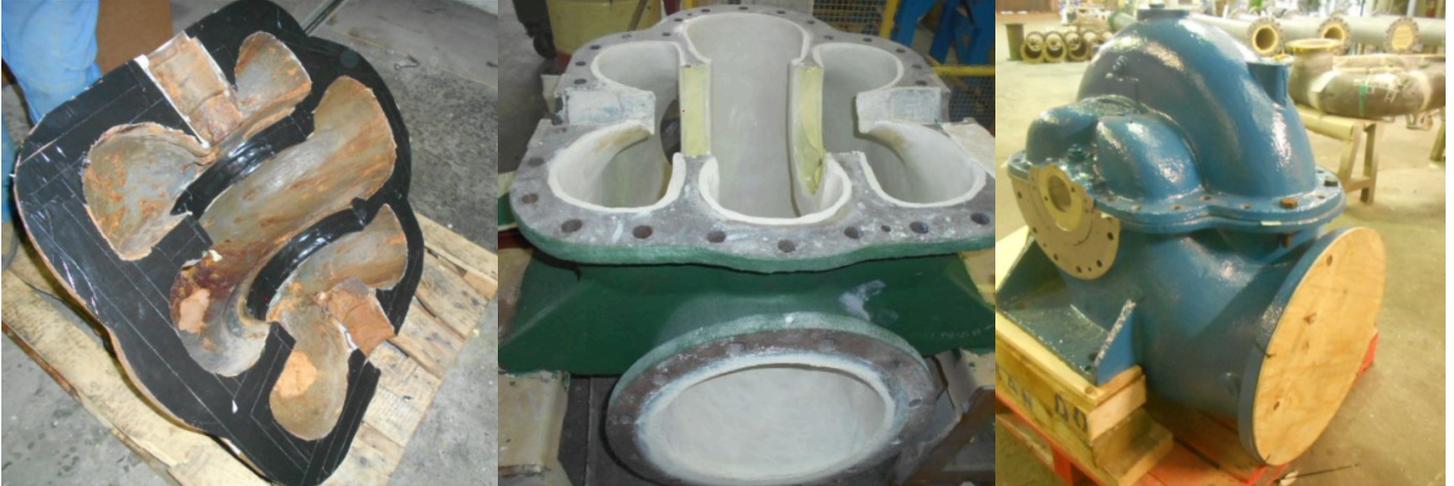
The HSC split pump casing and cover was received from the client, an initial inspection report was carried out. During the inspection the casing and cover were found to have suffered from severe erosion corrosion around the cutwater, discharge bend and stuffing box bores. The stationary wear ring landings had already been mechanically repaired by the client.

Internal areas - rebated all flanges, including the split face, to prevent crevice corrosion. Prepared and masked all areas not requiring treatment. Grit blasted all the internal areas requiring coating to ISO8501-1, Sa2.5. Applied a priming coating using Corroglass 632 to data sheet 1/11A. Built up the coating to a minimum dry film thickness of 1.25mm using Corroglass 602 to data sheet 1/10A. Thickness checked and spark tested (17Kv) External areas - Grit blasted to ISO8501 - 1 Sa2. Apply 2 coats of Plasmet ZF to data sheet 5/15A. Applied a top coat of industrial enamel to RAL5009 (Blue).

The casing has been repaired back to standard sizes at a fraction of the cost of replacing with new. The 600 series coating system will give this unit a life expectancy exceeding ten years.
