# DISPERSION TANK REFUB AND RE-COAT

## Dispersion/Mixing Tank at Motor Manufacturing Plant

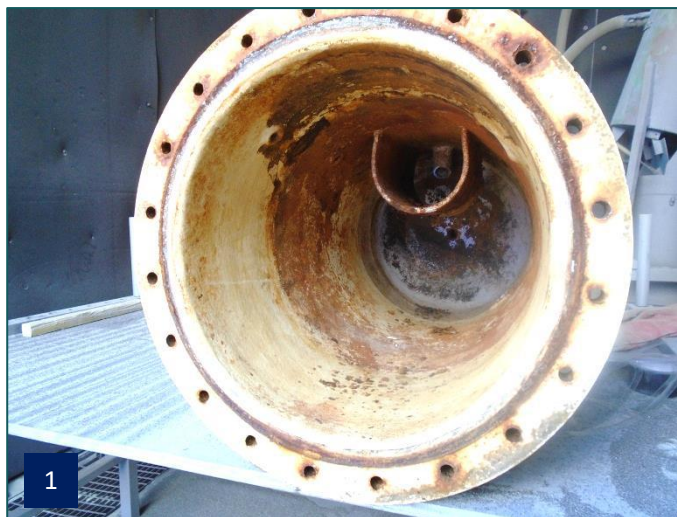
1

1: Condition of internals on arrival at Leeds workshop.  
2: Internals coated with Polyglass VEF.  
3: Before and after images of tank externals.

A dispersion/mixing tank in service at a large vehicle manufacturing plant was suffering corrosion due to the materials carried and dispersed within. The tank required a programme of refurbishment and lining with a suitable protective coating.

The tank was abrasive blasted, both internally and externally, to achieve the required cleanliness standard before being thoroughly cleaned down to remove all dust and debris.
