Steel Smelting.

We attended on-site to view and assess a corroded gas scrubber and demister at a blast furnace. Despite the age and corrosion levels of the assets it was determined that Corroserve could repair and coat the units to provide an extended life cycle to both units. Extensive preparation of the substrates together with additional repairs were to be carried out as the project evolved.

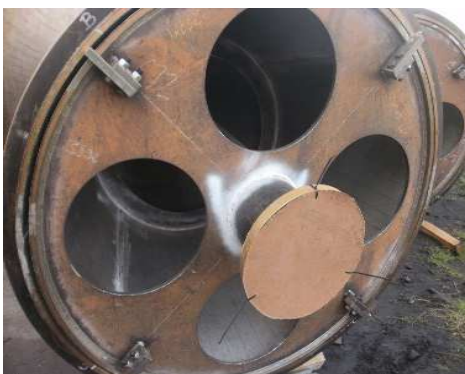
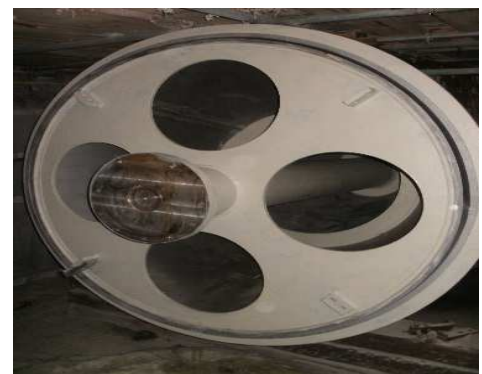
The coating applied needed to be excellent in environments across the pH scale, excellent resistance to solvents, acids and demineralised water. Polyglass VEF was recommended due to its exceptional hold up during application, providing superb chemical resistance, leading to a prolonged life of asset protection.
