## PIG LAUNCHER REQUIRED PROTECTION FROM CORROSION DUE TO STANDING WATER

### Pig Launcher

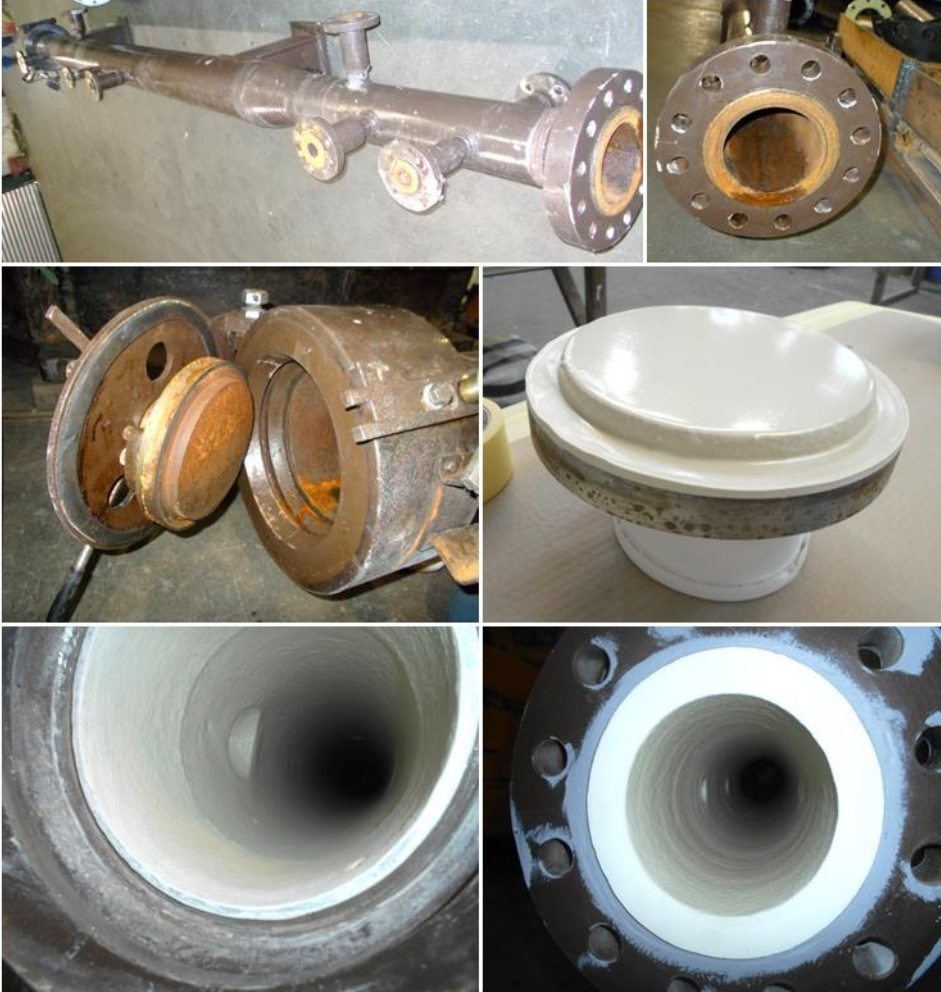
A pig launcher in service at a UK onshore oil field and processing facility required protection against corrosion caused by standing water that remains in the pipework between pig runs.

At Corrosolve's Leeds workshop the machined surfaces were masked prior to abrasive blasting followed by a blow down, sweep and vacuum to completely remove dust. Corroglass 600 was then applied, followed by Polyglass VEF to the required dft using the Agmec internal pipe-spraying system.

Once cured all surface protection was removed, edges dressed and a full visual inspection completed. Thickness testing and spark testing was also completed to ensure the quality of the finished coating system.

Corroglass 600 and VEF combined as a system will provide the best possible resistance to chemicals and temperature. The finished coating system will significantly extend the service life of the pig launcher.
