Protection for Pump Wetted Areas

Petrochemical, UK.

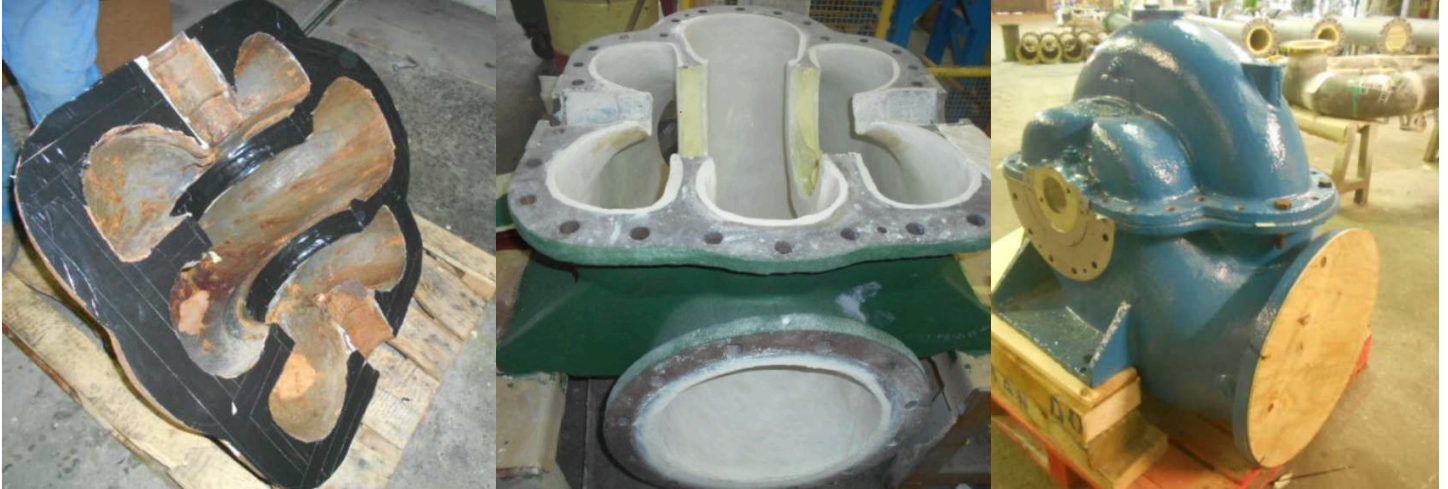
The HSC split pump casing and cover was received from the client, an initial inspection report was carried out. During the inspection the casing and cover were found to have suffered from severe corrosion around the cutwater, discharge bend and stuffing box bores. The stationary wear ring landings had already been mechanically repaired by the client.

Internal areas - rebated all flanges, including the split face, to prevent crevice corrosion. Prepared and masked all areas not requiring treatment. Grit blasted all the internal areas requiring coating to ISO8501-1, Sa2 1/2. Applied a priming coating using Corroglass 632 to data sheet 1/11A. Built up the coating to a minimum dry film thickness of 1.25mm using Corroglass 602 to data sheet 1/10A. Thickness checked and spark tested (17Kv). External areas - Grit blasted to ISO8501 - 1 Sa2. Apply 2 coats of Plasmet ZF to data sheet 5/15A. Applied a top coat of industrial enamel to RAL5009 (Blue).

The casing has been repaired back to standard sizes at a fraction of the cost of replacing with new. The 600 series coating system will give this unit a life expectancy exceeding ten years.
