Repair and Overhaul of four River Water Pumps following pump house flooding

A18/238

Gas Fired Power Station.

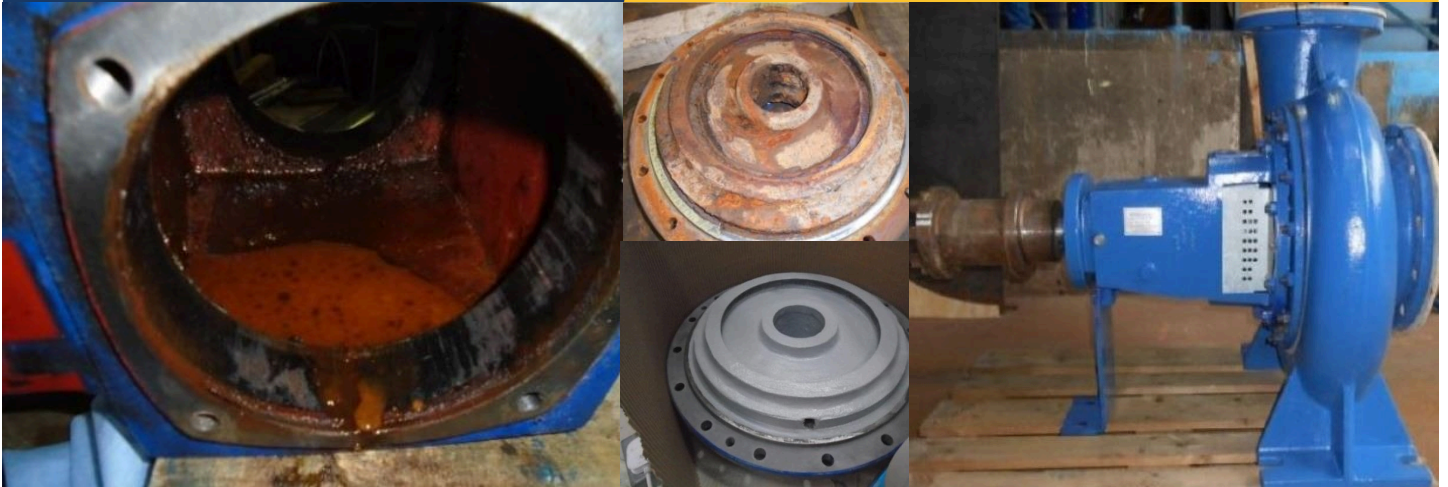
Each pump was taken out of service in turn and delivered to our workshop. After arrival the service team dismantled the pump and completed a strip and inspection report. As can be seen in the images above, the wetted areas suffered from erosion corrosion and due to flooding, the bearings were badly damaged.

The professional preparation of the wetted parts before coating and the use of Plasmert HTE ensured that the pumps will remain in service for many years.

The specialist coating used is designed to provide protection against corrosion in immersed locations and offers resistance to highly abrasive pumped products.
