A brief overview of some of the work Corroserve has completed at power plants across the UK. Corroserve has a proven track record of working with the UK Power Industry, providing long term protection of critical equipment.

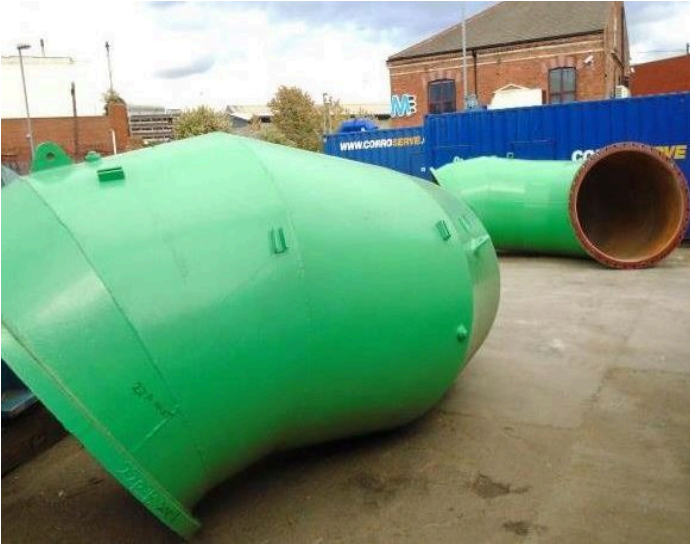
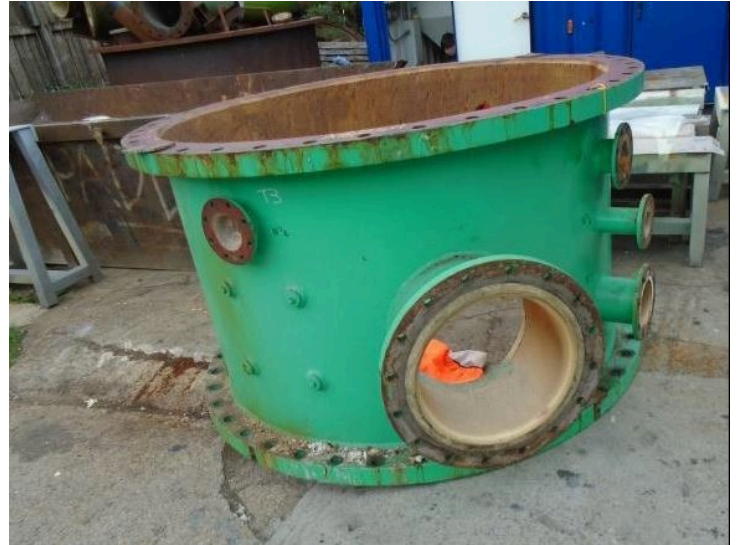
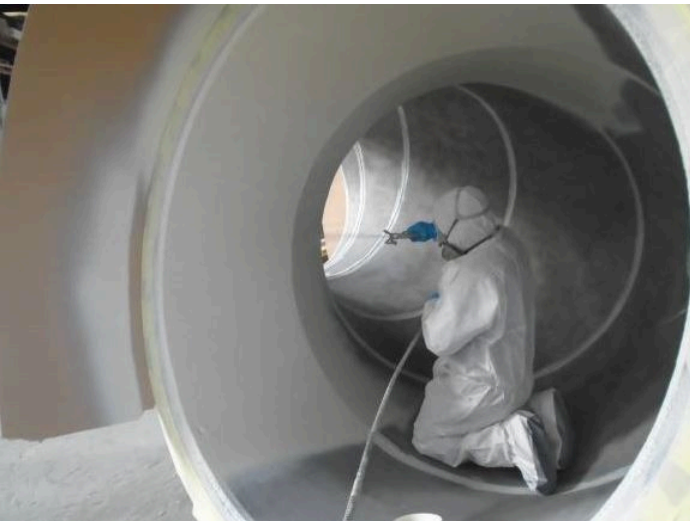
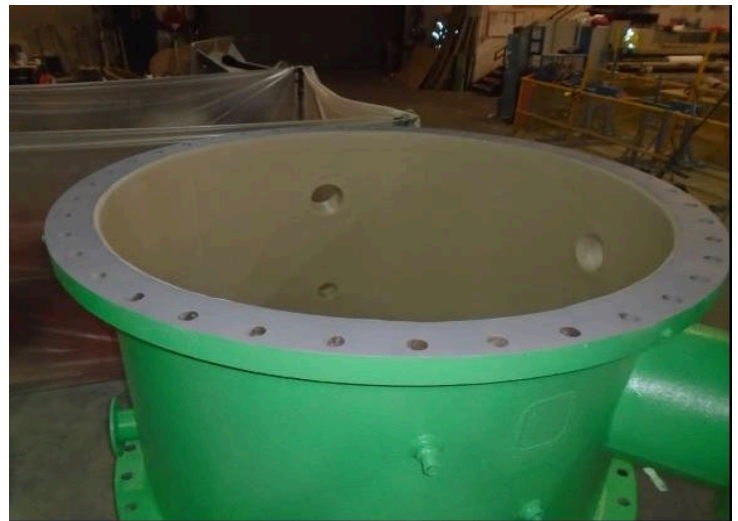
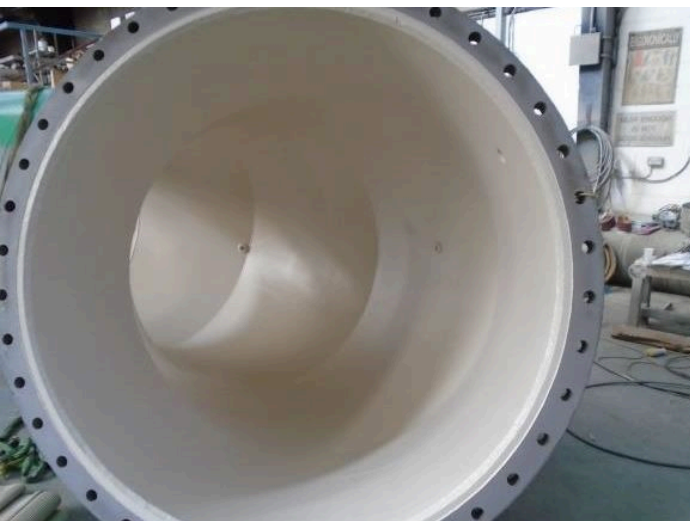
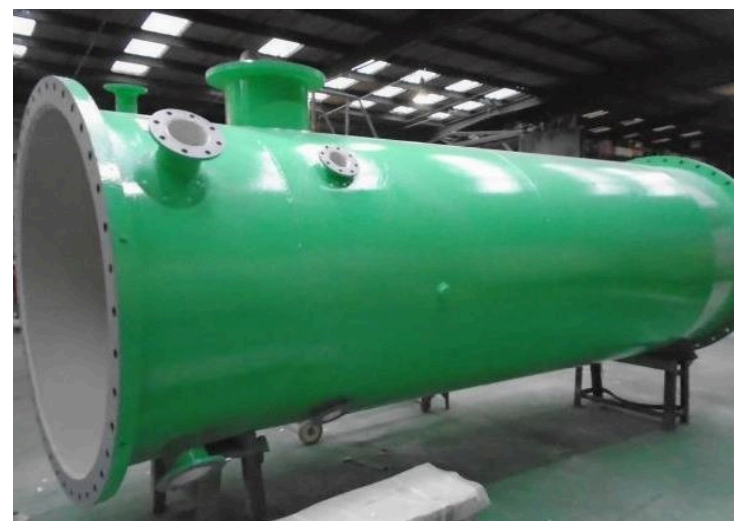
Above is an example of the work we carried out on condenser pipework and lobster-back, prepared and coated with Polyglass and Armagel to protect against corrosion and abrasion.

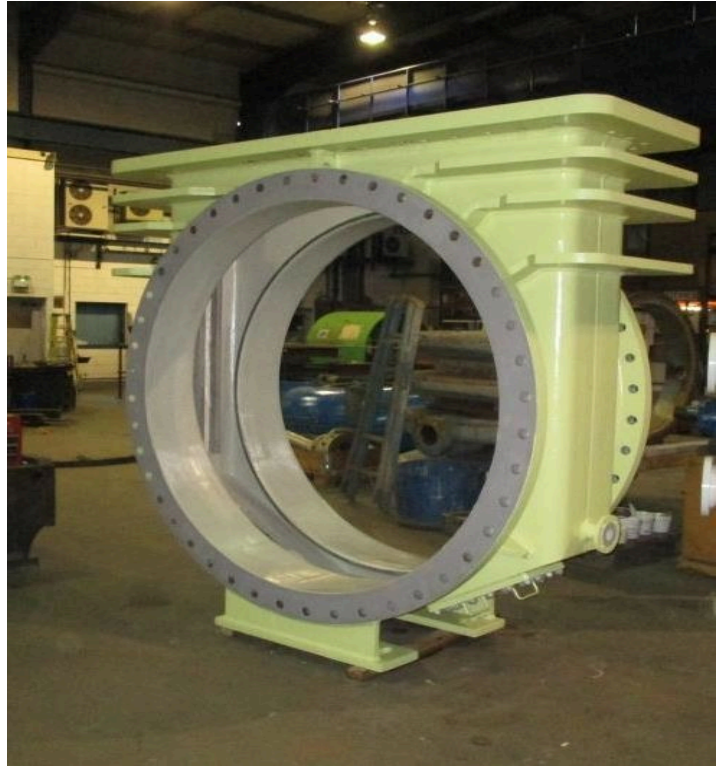
Image above showcases 72" NB gate refurbishment and corrosion protection.

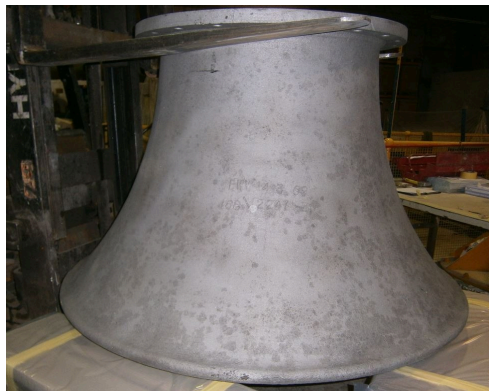
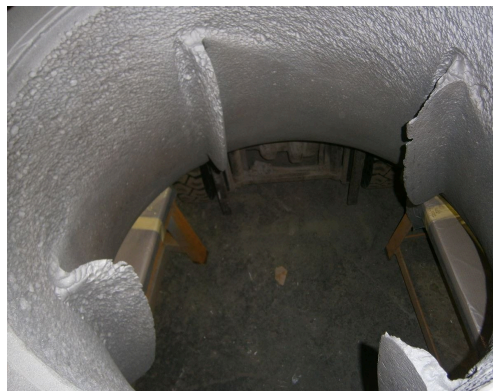
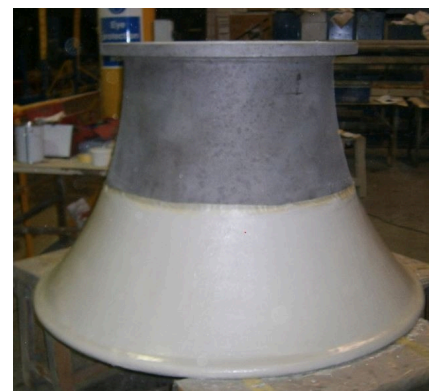
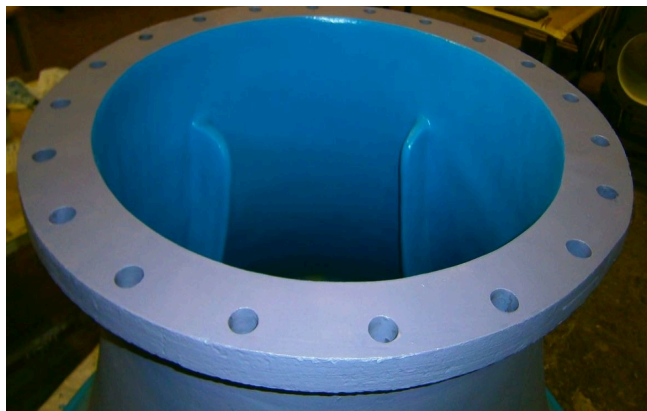
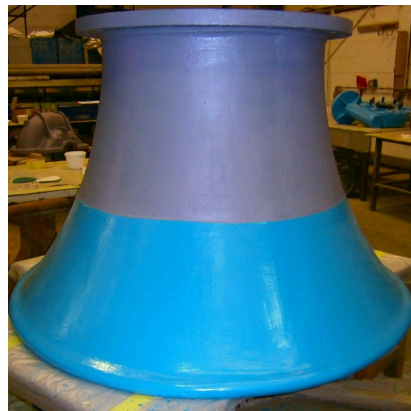
Power flares grit blasted to Sa2 1/2 with a surface profile of minimum 50 microns. Vanes repaired and flares refurbished and coated, using Corroglass 600 series.

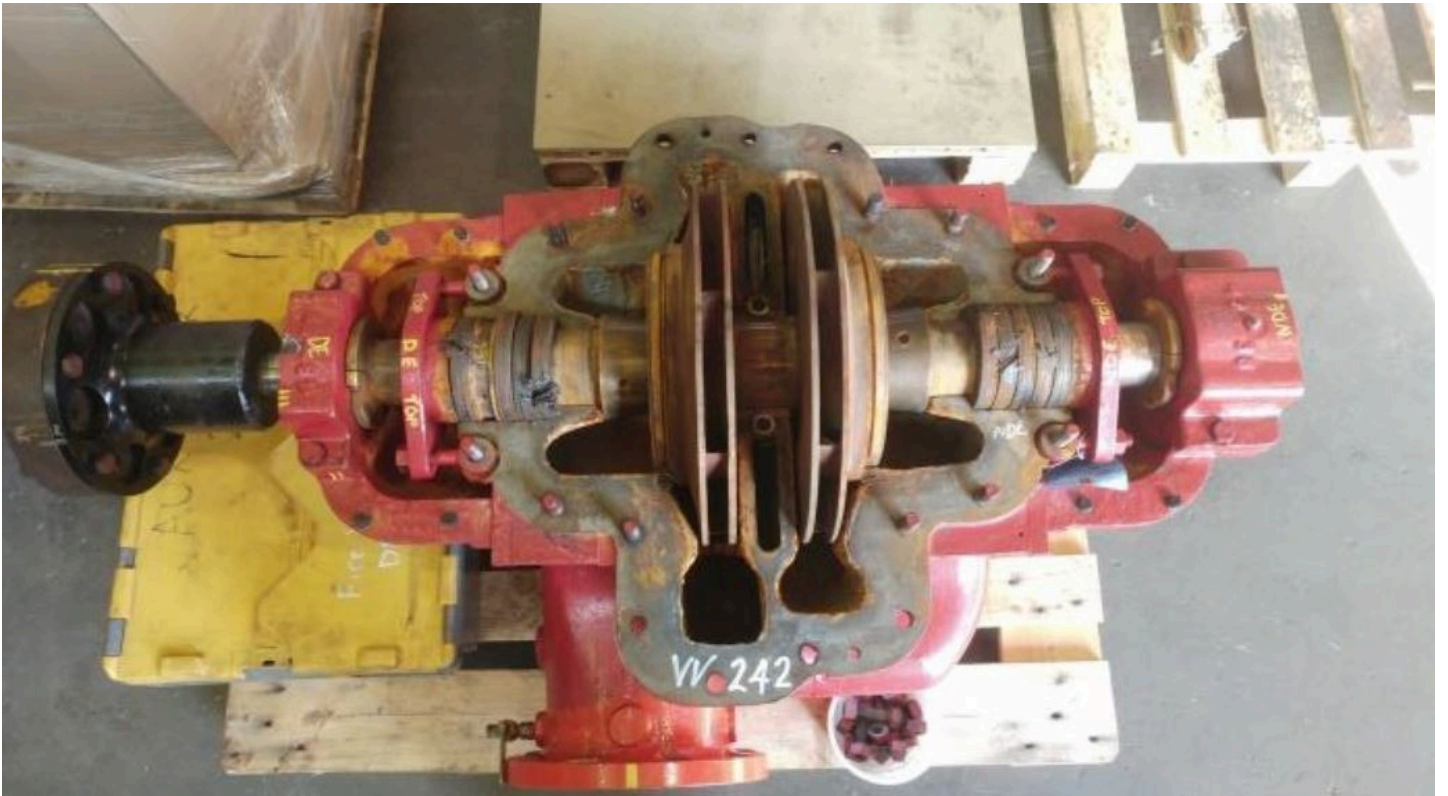
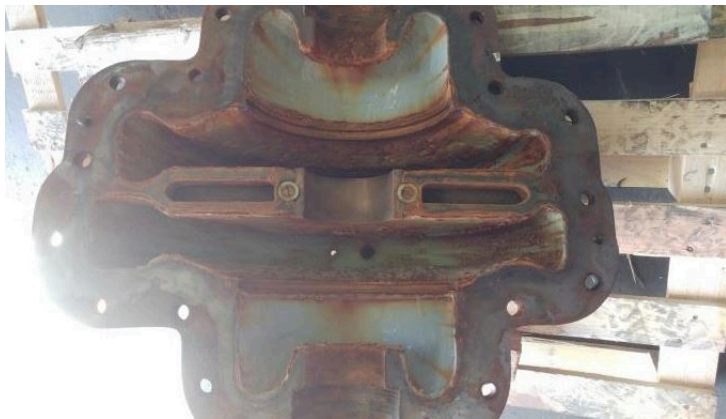
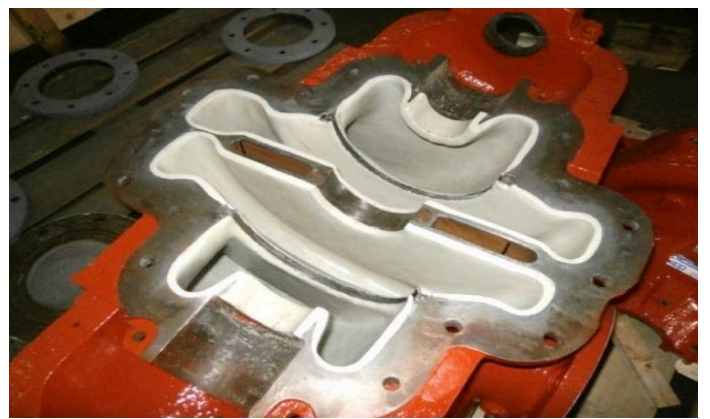
Refurbishment of horizontal split casing fire pump and protective lining with Corroglass 600 coating.

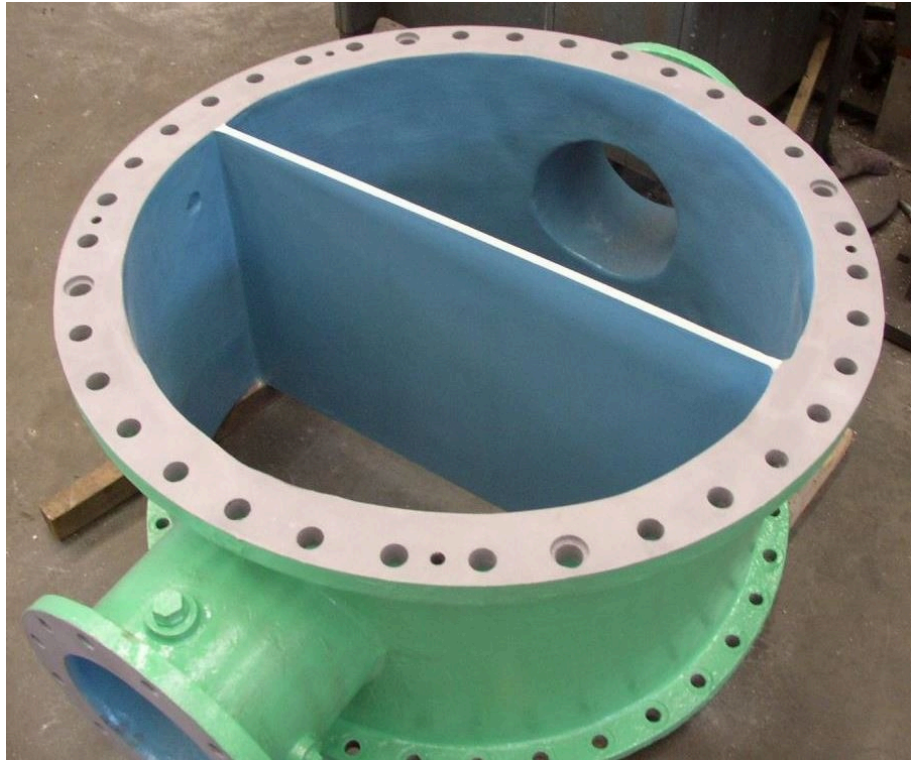
Image above of a water box in an extremely poor state, refurbished/rebuilt and protective coating Corroglass 600 applied.

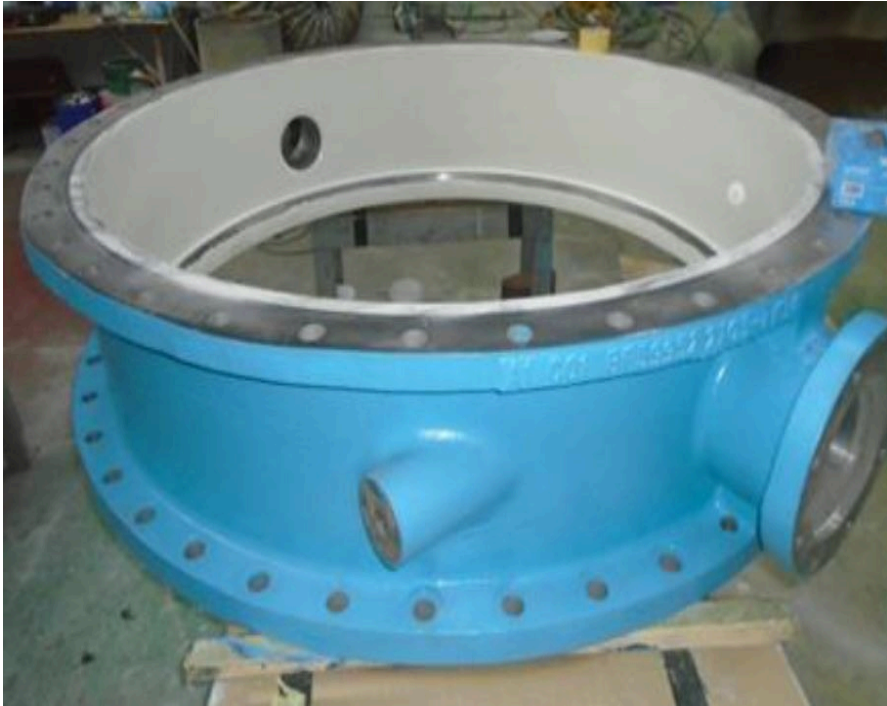
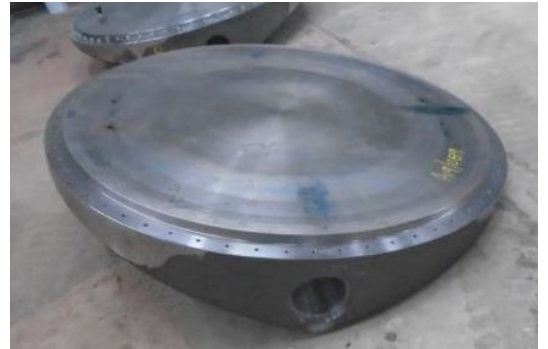
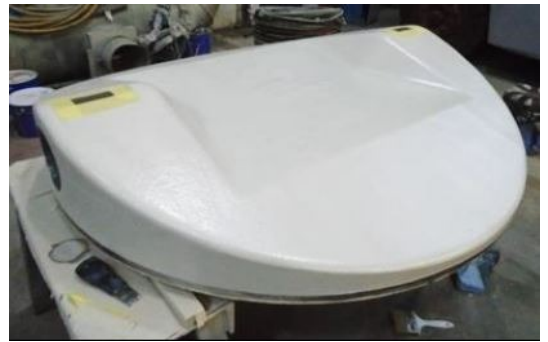
An example of a newly fabricated Butterfly valves corrosion protected.

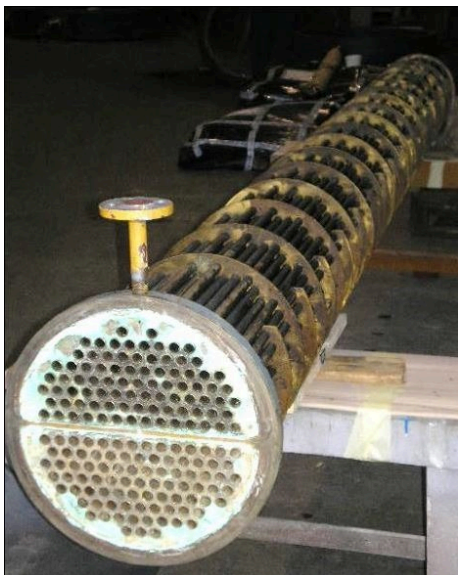
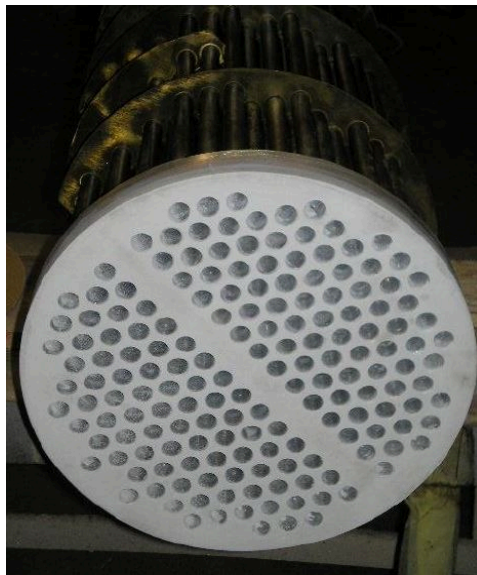
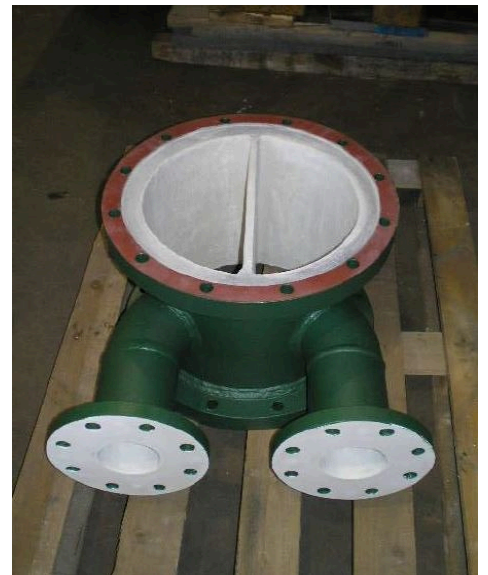
Example of a tube bundle cleaned and refurbished along with water box.

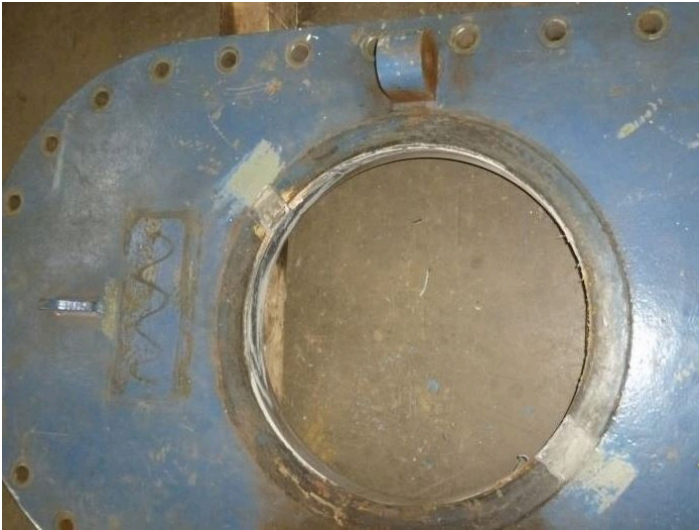
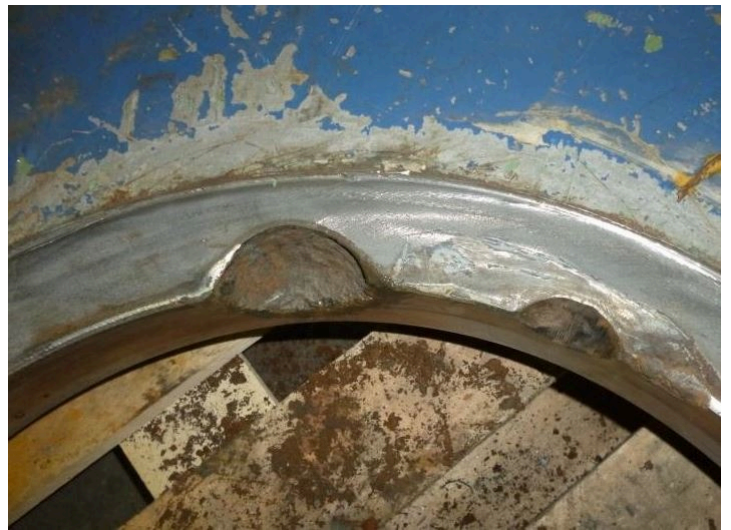
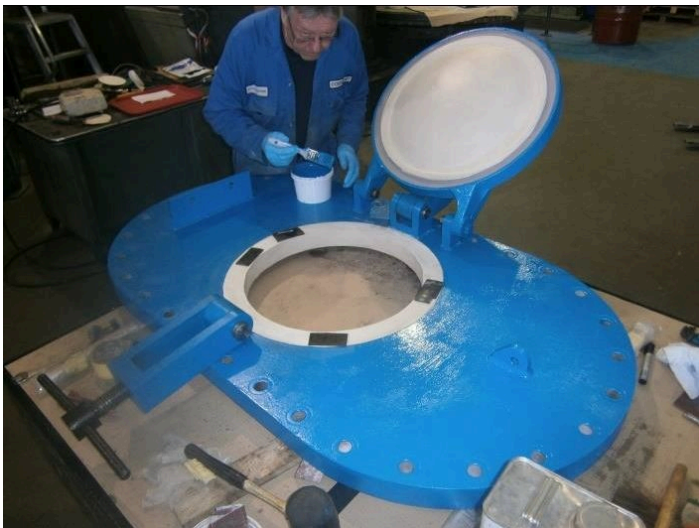
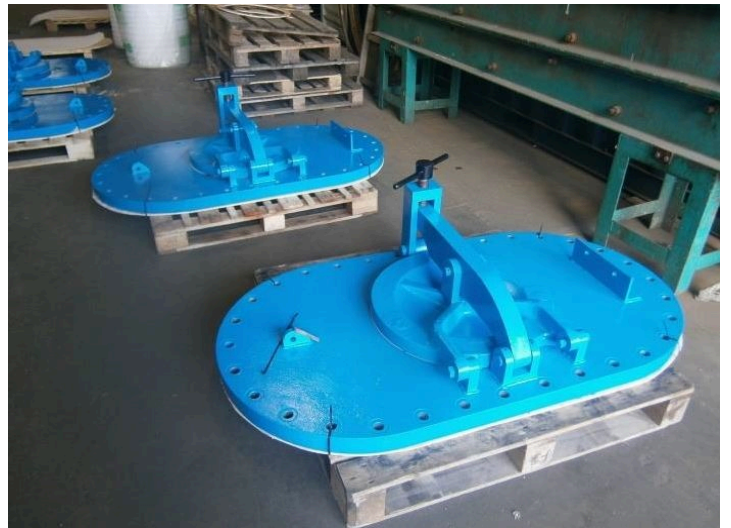
Images above show main cold-water submarine water box doors repaired and protected with Corroglass 600.
