An industrial operator handling brine and water services required urgent refurbishment of a critical horizontal split case (HSC) pump to restore performance and prevent further operational risk.

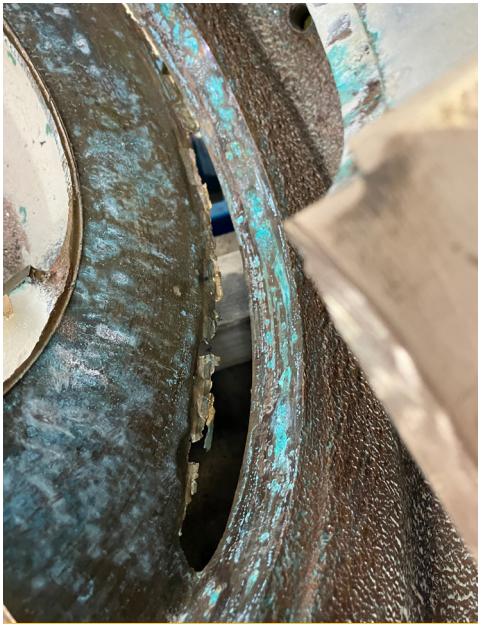
Caption

During operation, the pump experienced a bearing failure which caused the impeller to shift within the casing.

This resulted in significant internal damage to the phosphor bronze casing, including:

- Severe wear at the impeller landing areas
- Compromised casing integrity
- Increased risk of reduced efficiency and potential failure
- Given the aggressive nature of the brine environment, a robust and long-term repair solution was essential.

- Installation of phosphor bronze rings in both upper and lower casing halves
- Assembly and precision machining to suit new wear rings, ensuring correct tolerances and clearances
- Rebate machining of upper and lower casing sealing faces
- Abrasive blasting of all internal surfaces to achieve the required cleanliness and surface profile

- Application of multi-directional GRP matting, wetted with L600 laminating resin, to rebuild and reinforce damaged areas
- Full internal coating using Corroglass 600 series, applied to a minimum dry film thickness (DFT) of 1250 microns

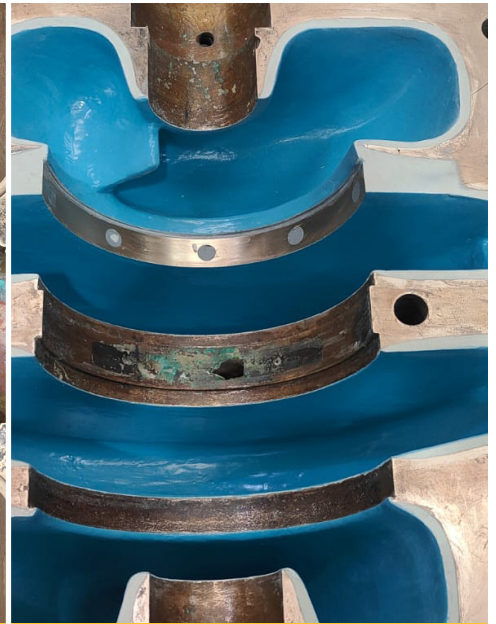
Caption

- Fully restored casing integrity and functionality
- Improved resistance to corrosion and chemical attack
- Enhanced pump efficiency through correct clearances and surface finish
- Extended service life of the asset in a highly aggressive environment
