# **CORROCOAT**

## **LONG-TERM CORROSION PROTECTION AND PERFORMANCE RESTORATION OF A NASH VACUUM PUMP CL 3000**

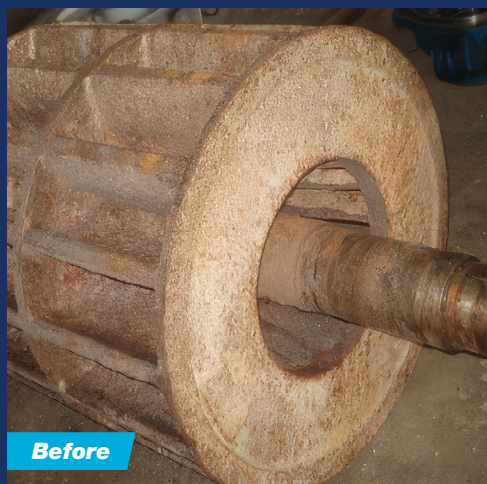
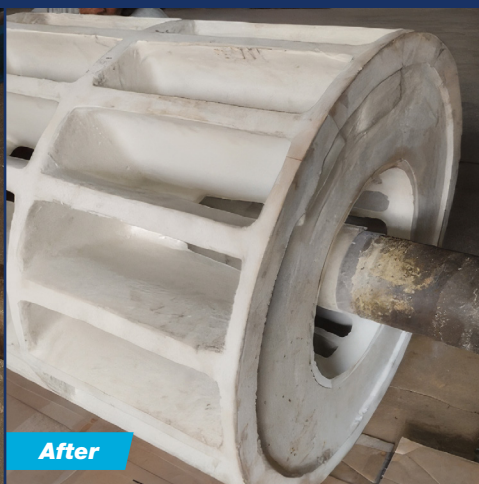
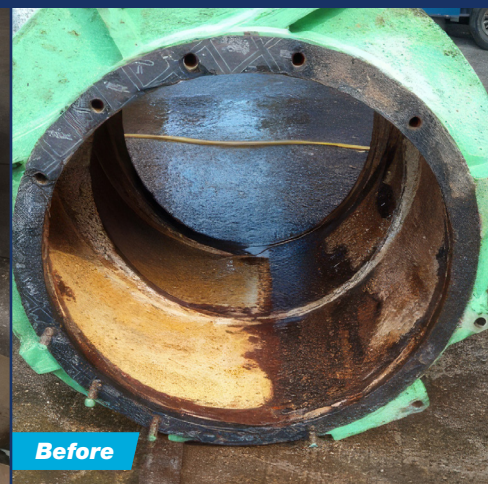
The pump had originally been refurbished and coated with Corroglass 600 Series in 2013. Following inspection and cleaning in 2026, the protective coating applied to the cover, cone and rotor was largely in good condition. However, wear was identified within the casing eccentric area, where the rotor, process fluid and entrained debris interact.

The scope of work included detailed inspection and dimensional assessment of the pump components, machining to restore geometry, abrasive blast surface preparation and application of the Corroglass 600 Series coating system.

Following coating application, critical clearances were reinstated through precision machining. The rotor was balanced, consumable components including bearings, gaskets and gland packing were replaced, and the pump was reassembled with cone-to-rotor tolerances accurately set.

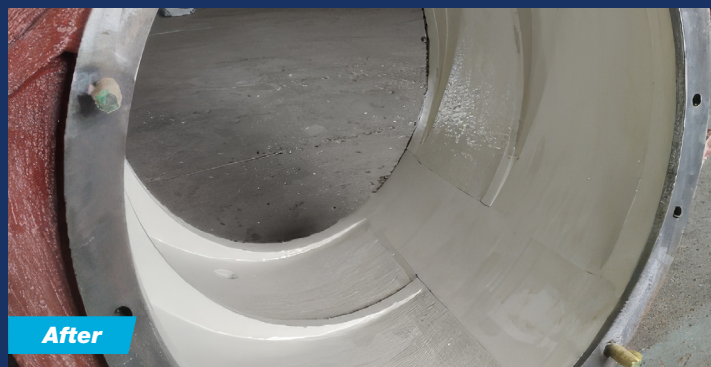
The refurbishment successfully restored both corrosion protection and mechanical performance.

Corroglass 600 Series continued to provide protection to wetted and exposed surfaces after more than 13 years of service, while precision engineering works addressed wear within critical operating areas. The combined approach enabled suction performance to be restored and the pump returned to service.
