CORROGLASS 600, ARMAGEL, PLASMET ZF AND CORROTHANE AP1 TEAM UP TO BRING NEW LIFE TO A POWER STATION PIPESPOOL

Pipe Section Refurbishment

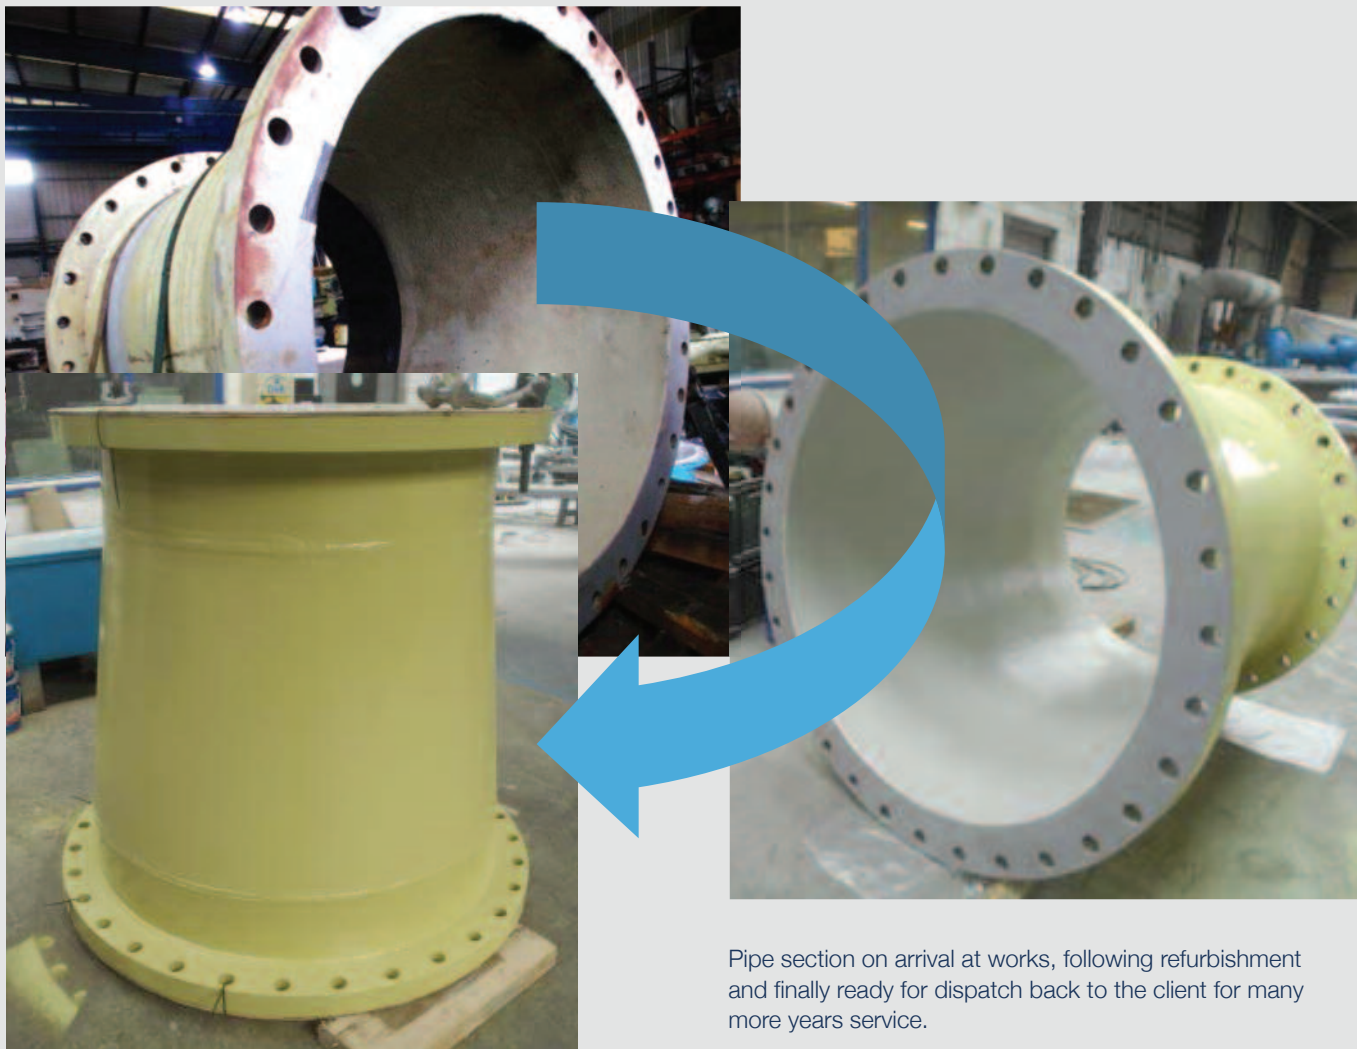
Pipe section on arrival at works, following refurbishment and finally ready for dispatch back to the client for many more years service.

The images show the pipe section on arrival and after the full refurbishment programme was completed and the section was prepared to be shipped back to the client for many more years active service.

Four products from the Corrocoatrangle were used in the refurbishment of a 1200/1000mm pipespool from a Scottish power station.

To begin the pipe section was blasted to SA2½ to achieve a surface profile of at least 50µm, and following a blow down, sweep and vacuum clean Corroglass 600 was applied to the internals at the required 750µm DFT.

Once cured and spark tested Armagel was applied to a DFT of 1250µm to provide resistance to both chemical attack and abrasion.

The external profile of the pipe section was then coated with Plasmert ZF followed by a topcoat of Corrothane AP1 for a high gloss protective finish.
